Test report no.: 16/655/0276

Title: Tensile and bending test on sheet piling clutch bars

Client: SteelWall ISH GmbH
Tassilostr. 21
82166 Gräfelfing

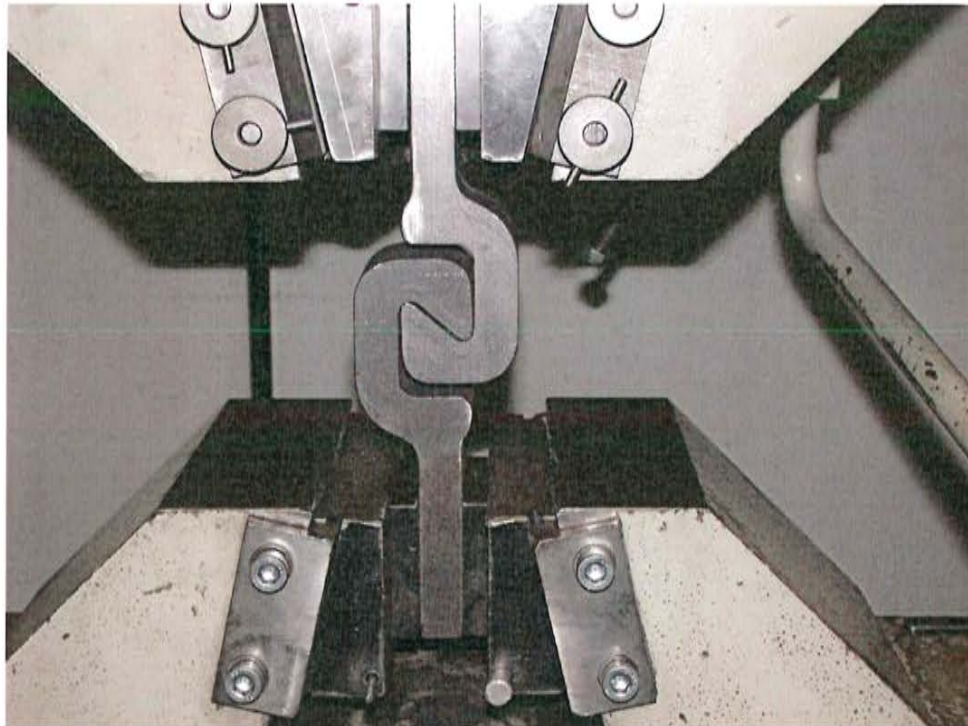
Figure 1:
Overview photo, sample no. 1 (LBP300-20),
Test setup

To determine the failure behaviour under tensile stress, tensile tests were performed on paired clutch bars. To perform these tests a standard tensile test machine (type Schenck-Trebel UPM400) was used. The clutch bars were cut into stripes approx. 50 mm wide, paired, clamped and axial tensile stress was applied, with continually increased pulling force until failure of the connection between the clutch bars by deformation or until break of a part. The tensile test essentially follows ISO 6892-1:2009 B, with a constant tension increase speed between 6 MPa/s and 60 MPa/s.

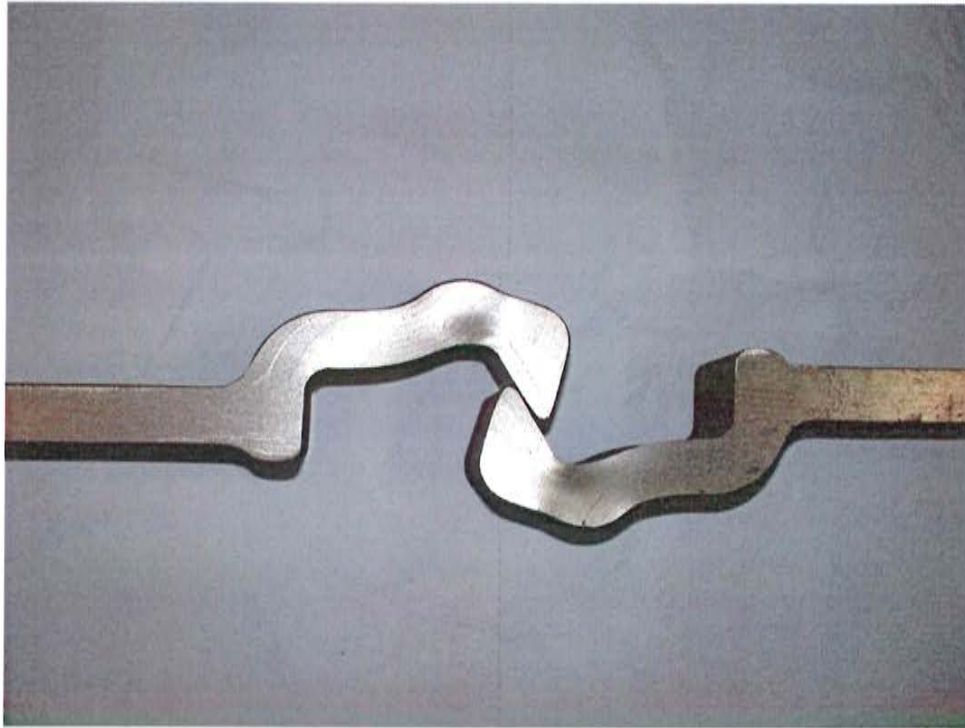
Figure 2:
Overview photo, sample no. 1 (LBP300-20),
after test, failure by deformation

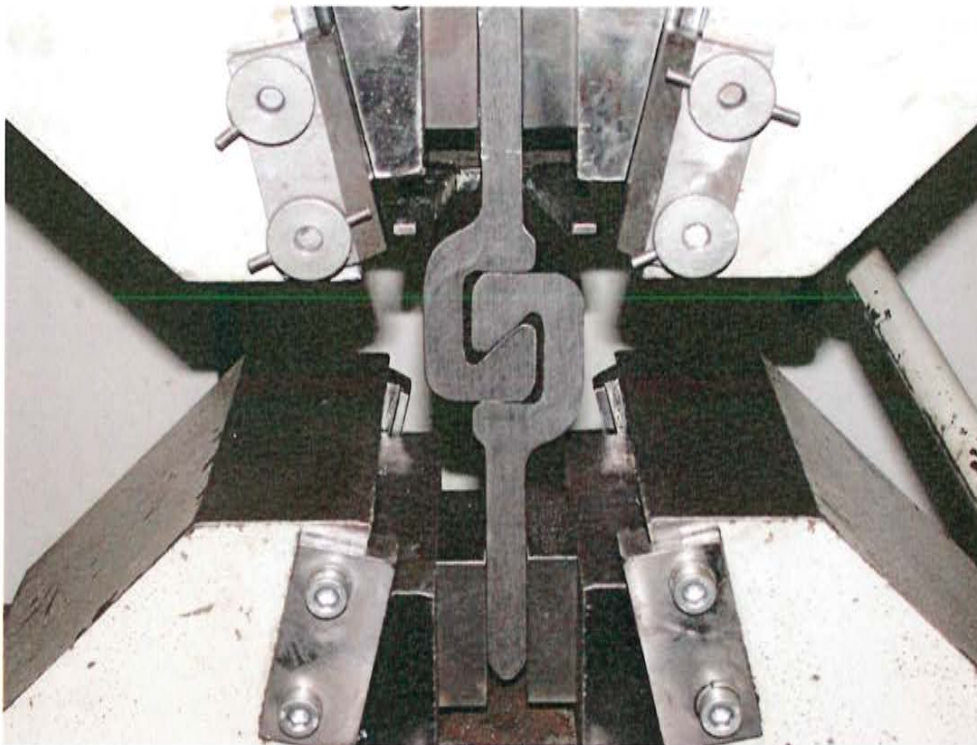
Figure 3:
Overview photo, sample no. 4 (LBP300-16),
Test setup

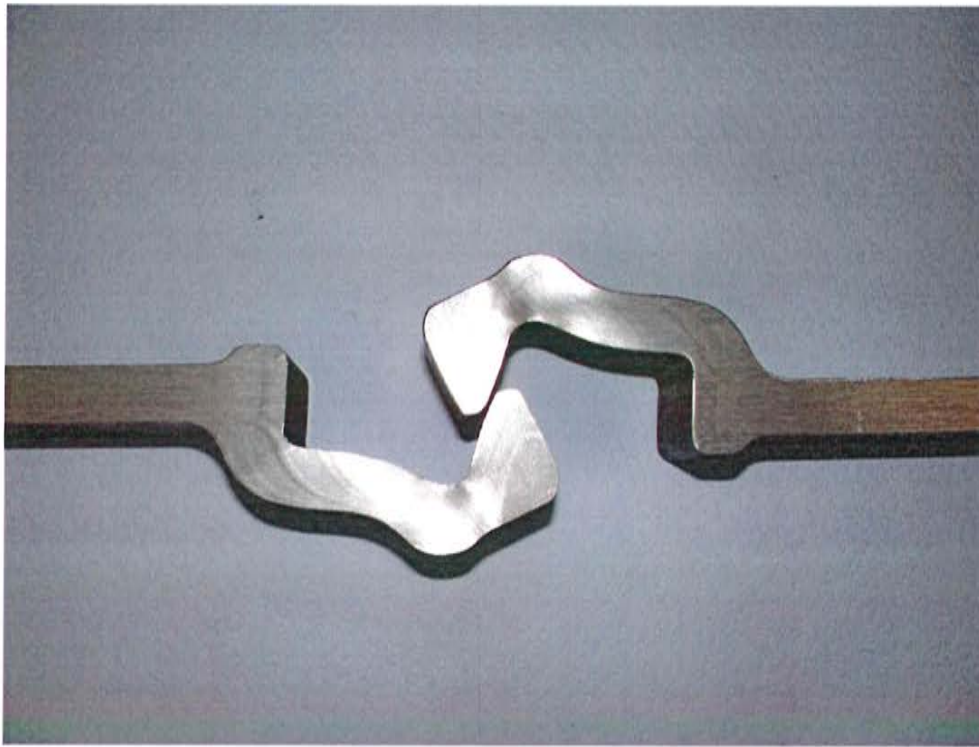
Figure 4:
Overview photo, sample no. 4 (LBP300-16),
after test, failure by deformation

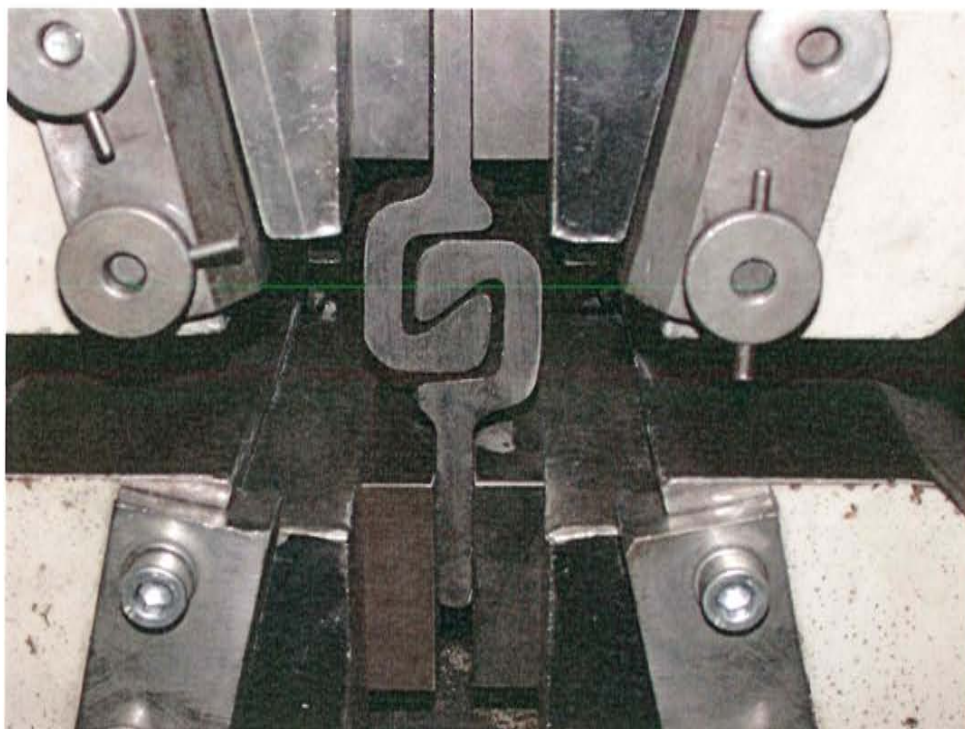
Figure 5:
Overview photo, sample no. 7 (LBP180-12),
Test setup

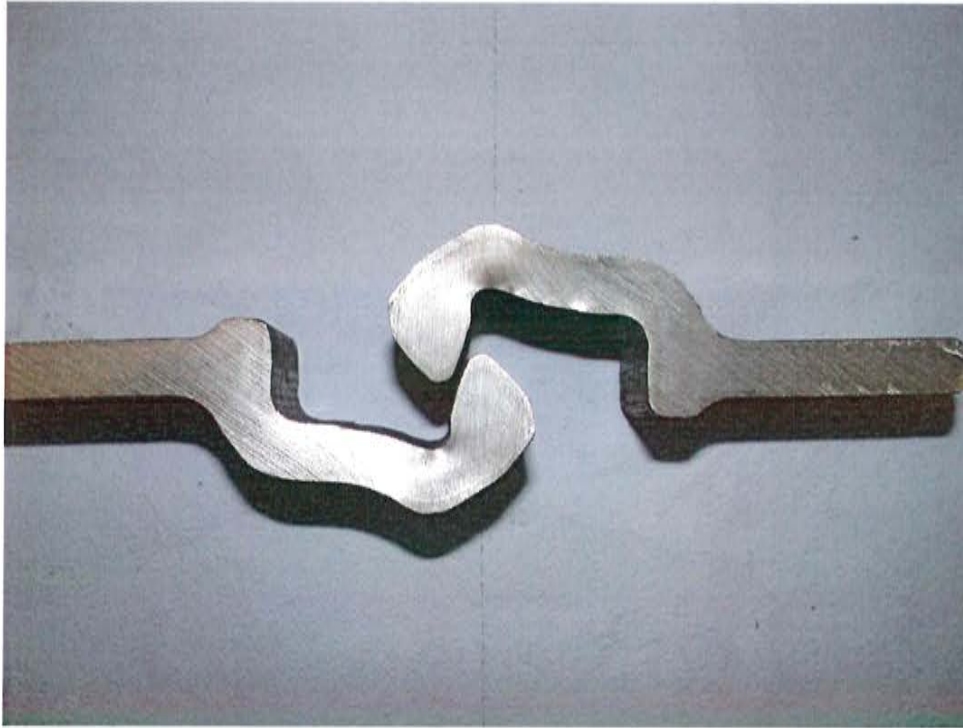
Figure 6:
Overview photo, sample no. 7 (LBP180-12),
after test, failure by deformation

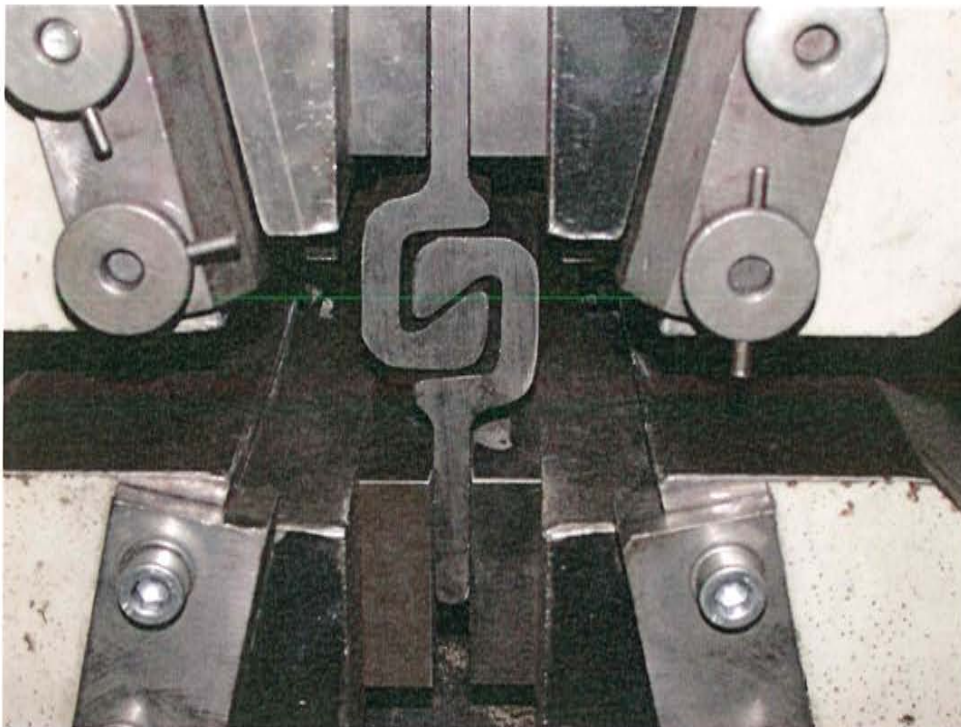
Figure 7:
Overview photo, sample no. 11 (LBP180-10),
Test setup

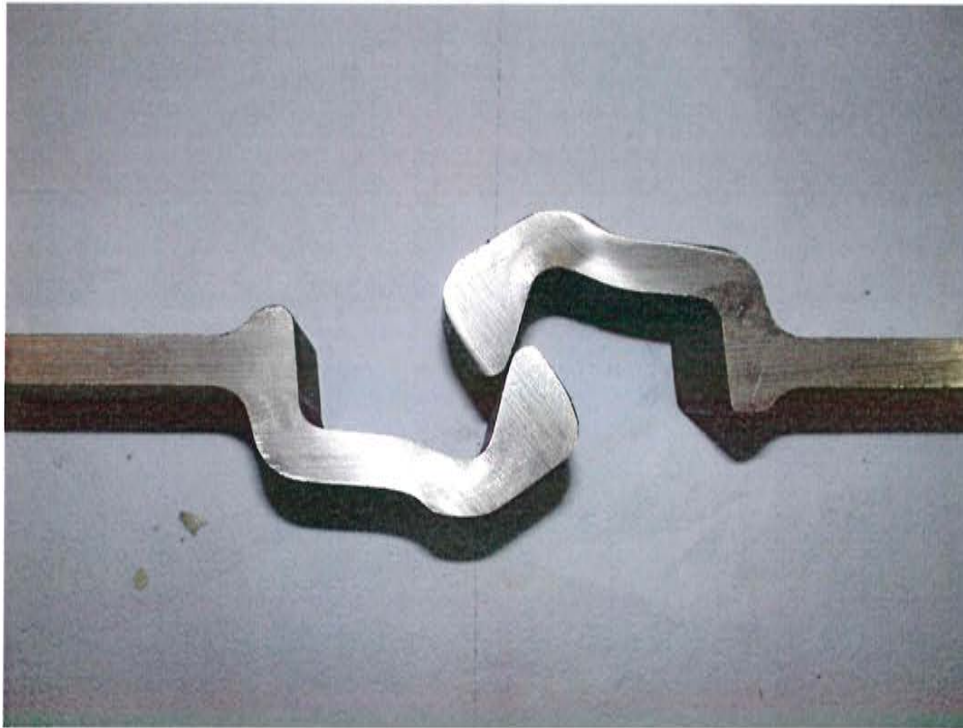
Figure 8:
Overview photo, sample no. 11 (LBP180-10),
after test, failure by deformation

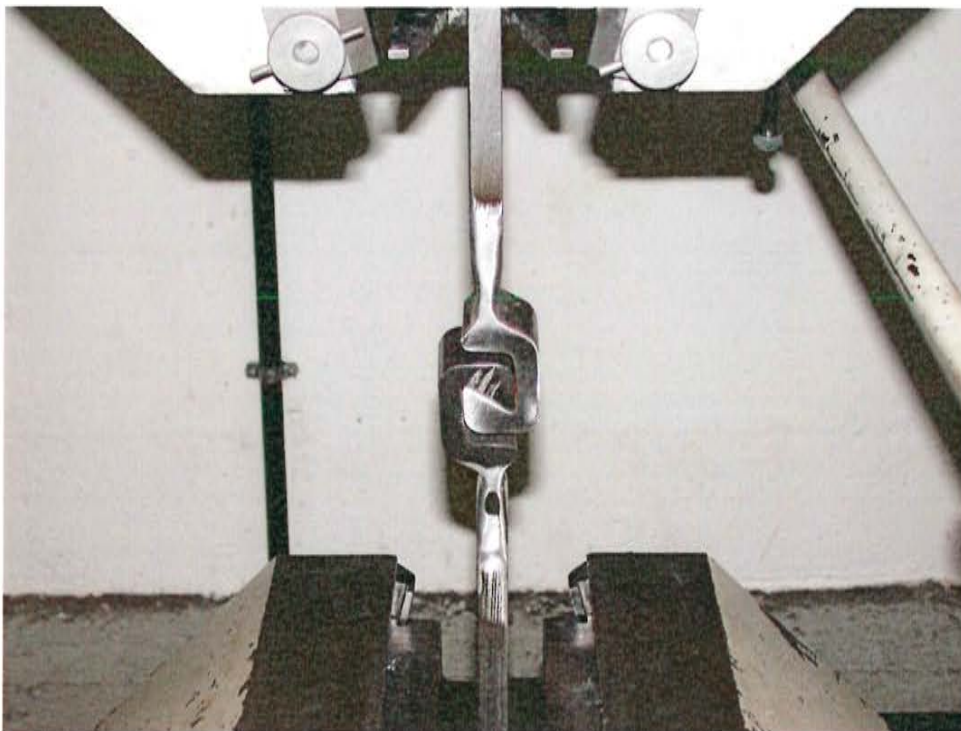
Figure 9:
Overview photo, sample no. 14 (LBP100-10),
Test setup

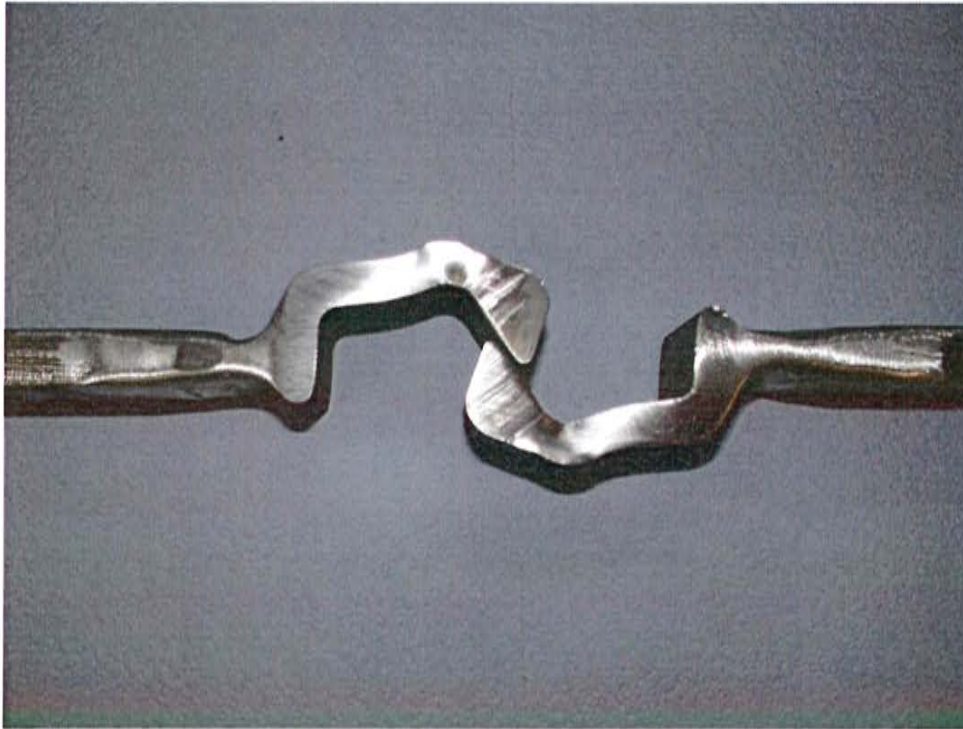
Figure 10:
Overview photo, sample no. 14 (LBP100-10),
after test, failure by deformation

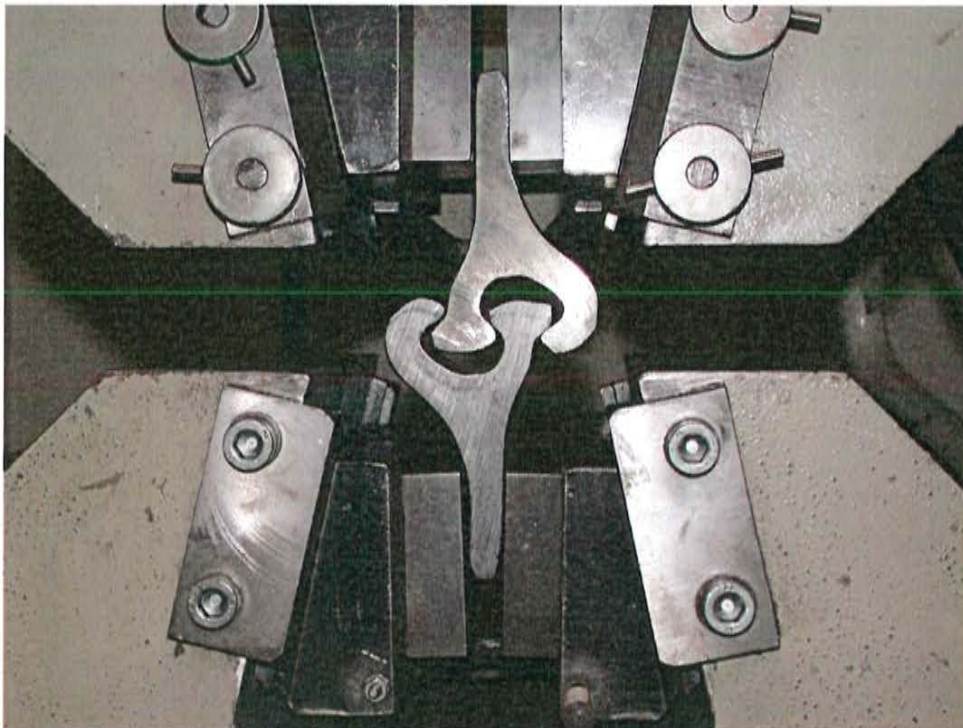
Figure 11:
Overview photo, sample no. 17 (FD180-12),
Test setup

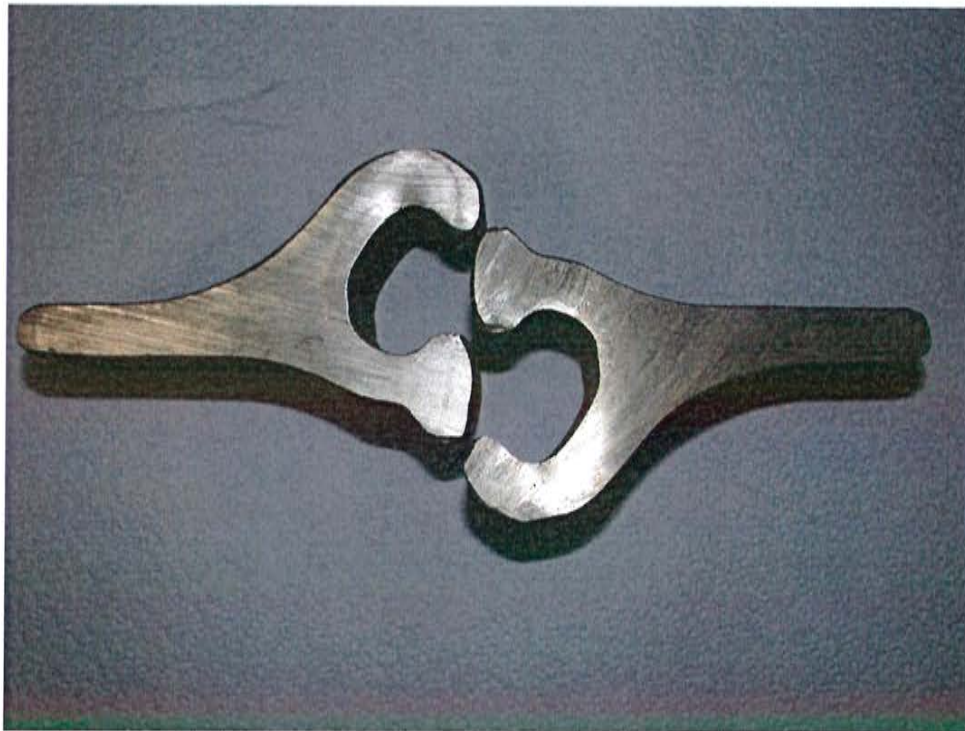
Figure 12:
Overview photo, sample no. 17 (FD180-12),
after test, failure by deformation

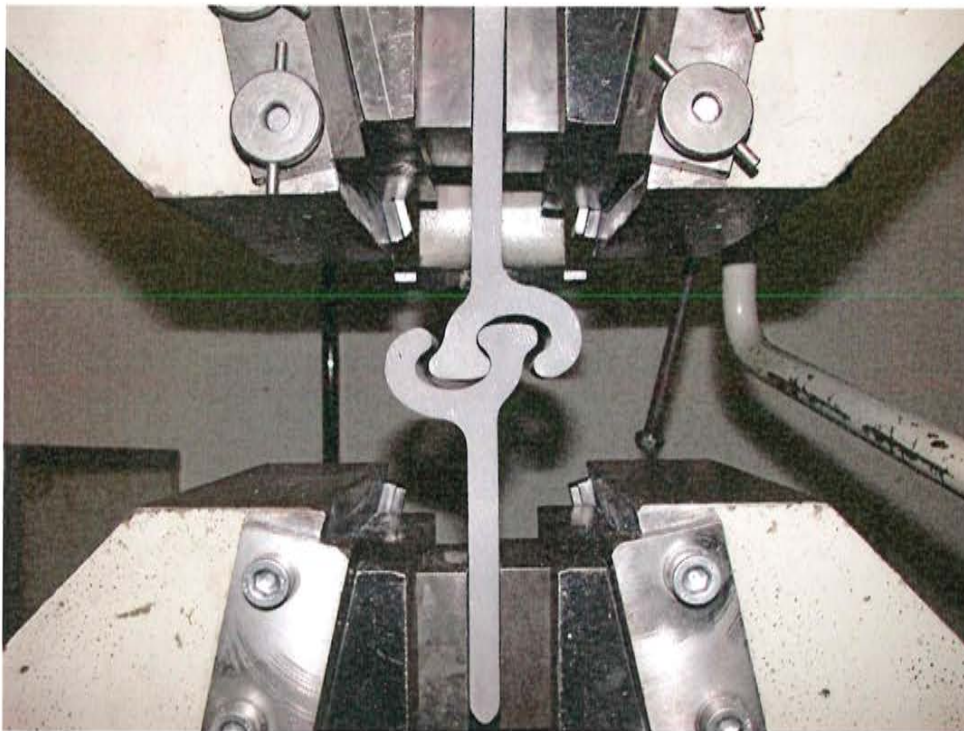
Figure 13:
Overview photo, sample no. 19 (FD300-12),
Test setup

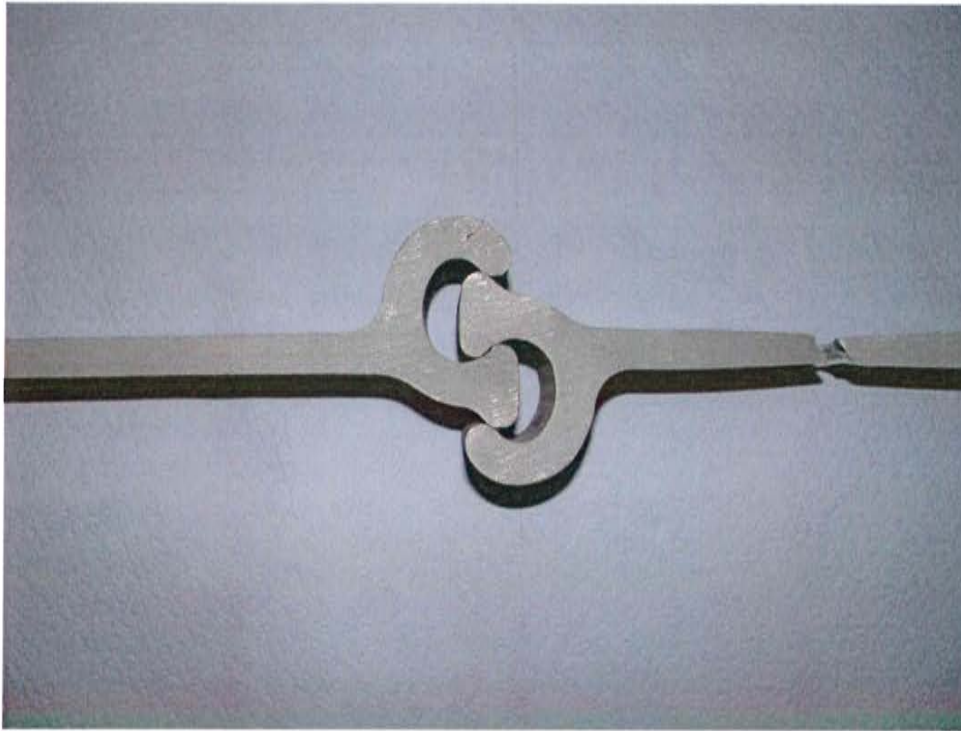
Figure 14:
Overview photo, sample no. 19 (FD300-12),
after test, failure by break

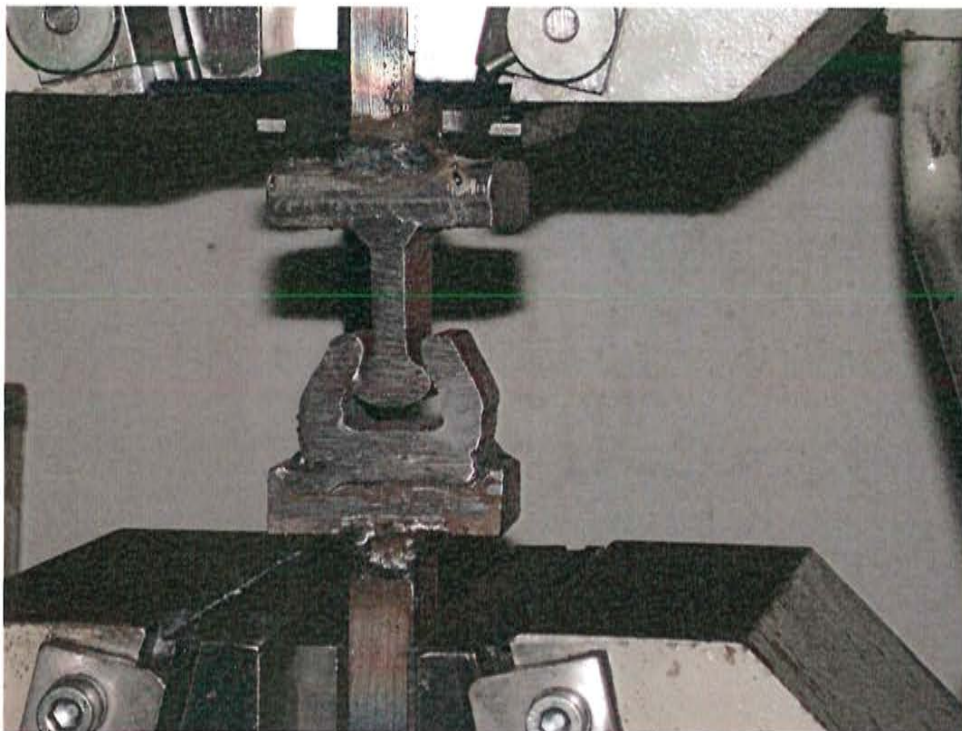
Figure 15:
Overview photo, sample no. 21 (PZM/PZF),
Test setup

In order to take up the samples of profile types LBP100-10 and PZM-US / PZF-US in the clamping device of the test machine, the corresponding extension pieces were welded to the clutch bars (see figure 15). The tensile tests on the individual clutch bars are documented in the figures 1 to 16, each with a picture before and after the test.

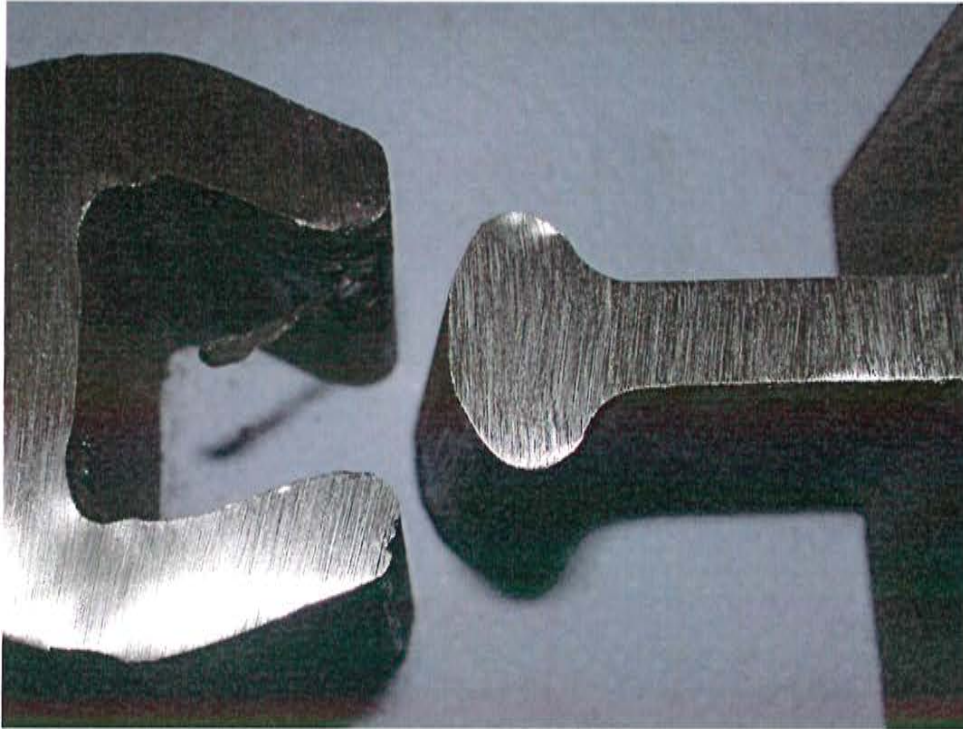
Figure 16:
Overview photo, sample no. 21 (PZM/PZF),
after test, failure by deformation

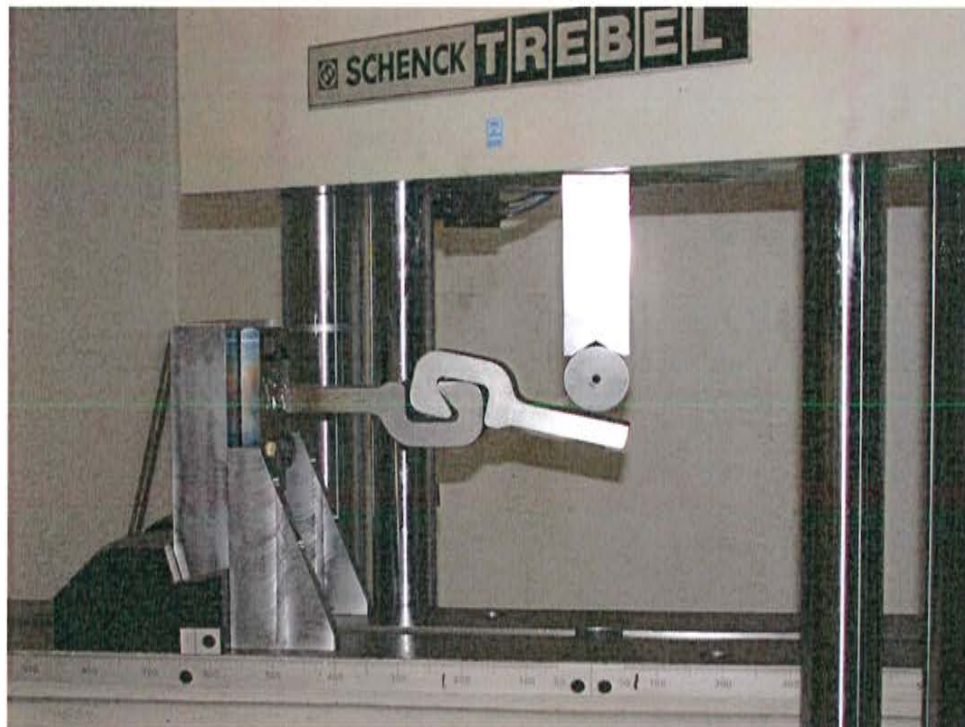
Figure 17:
 Overview photo, sample no. 2 (LBP300-20),
 Test setup

To take up the clutch bar pair, one was welded to a sheet, which was screwed to the supporting block (fixed clamping). A bending mandrel with diameter 40 mm was chosen as bending stamp. The point of attack for the bending stamp is at the outside of the second clutch bar. The maximum occurring force F_m at deformation during the test performance was determined as well. Figures 17, 20, 23, 26, 29 and 32 show the respective test setup and the samples before the bending test. Figures 18, 19, 21, 22, 24, 25, 27, 28, 30, 31, 33 and 34 document the respective clutch bar after the bending test. The deformation in this stress only took place in the area of the welding vane and the welding connection in all samples. The clutch bars did not show any recognizable deformation. The results from these part bending tests can be taken from the following table in typical, internationally common units.

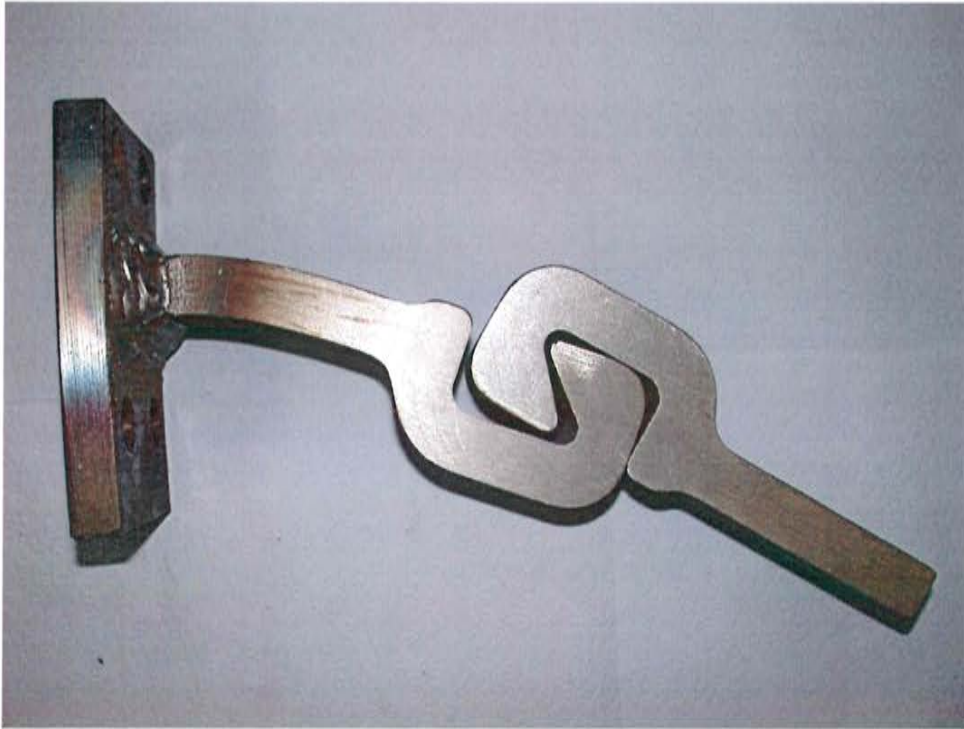
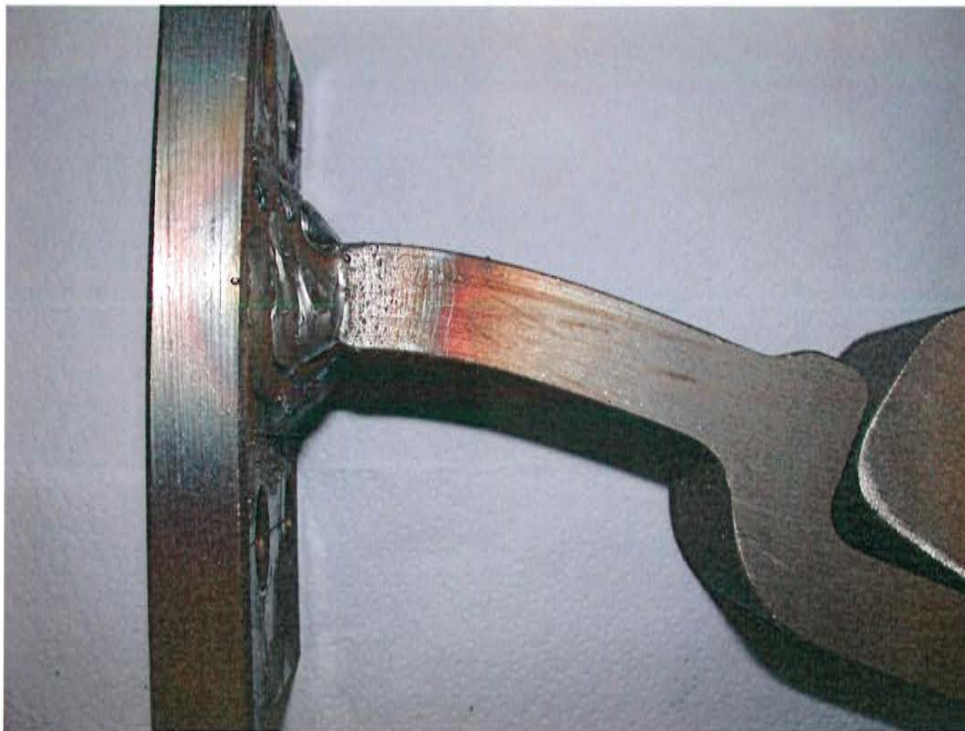
Figure 18:
Overview photo, sample no. 2 (LBP300-20),
Deformation after test

Figure 19:
Overview photo, sample no. 2 (LBP300-20),
Deformation after test

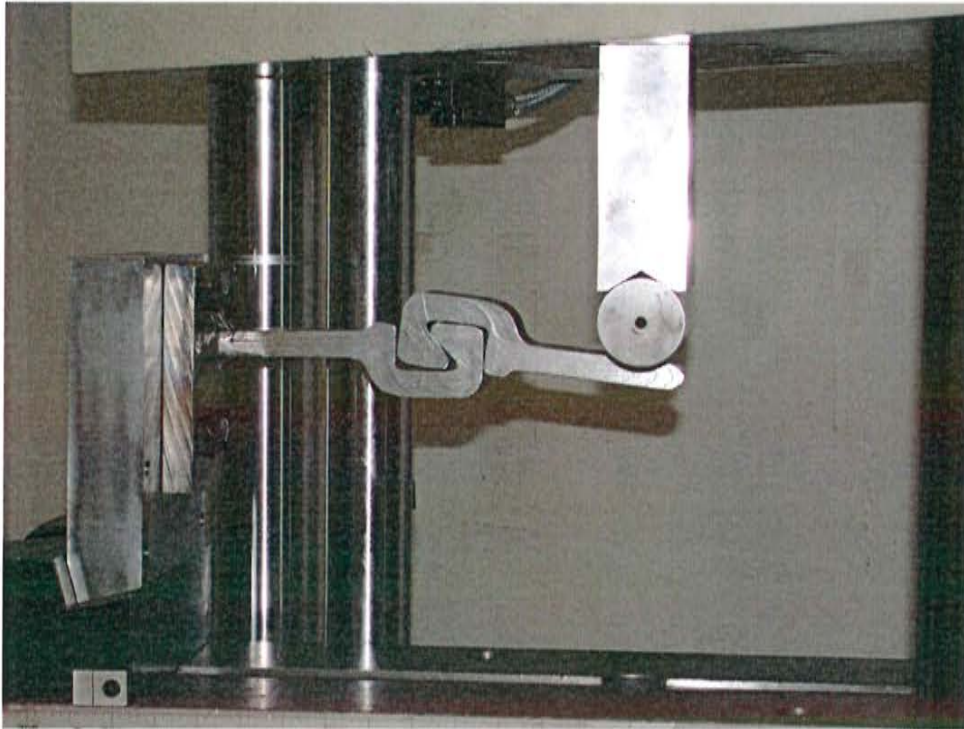
Figure 20:
Overview photo, sample no. 5 (LBP300-16),
Test setup

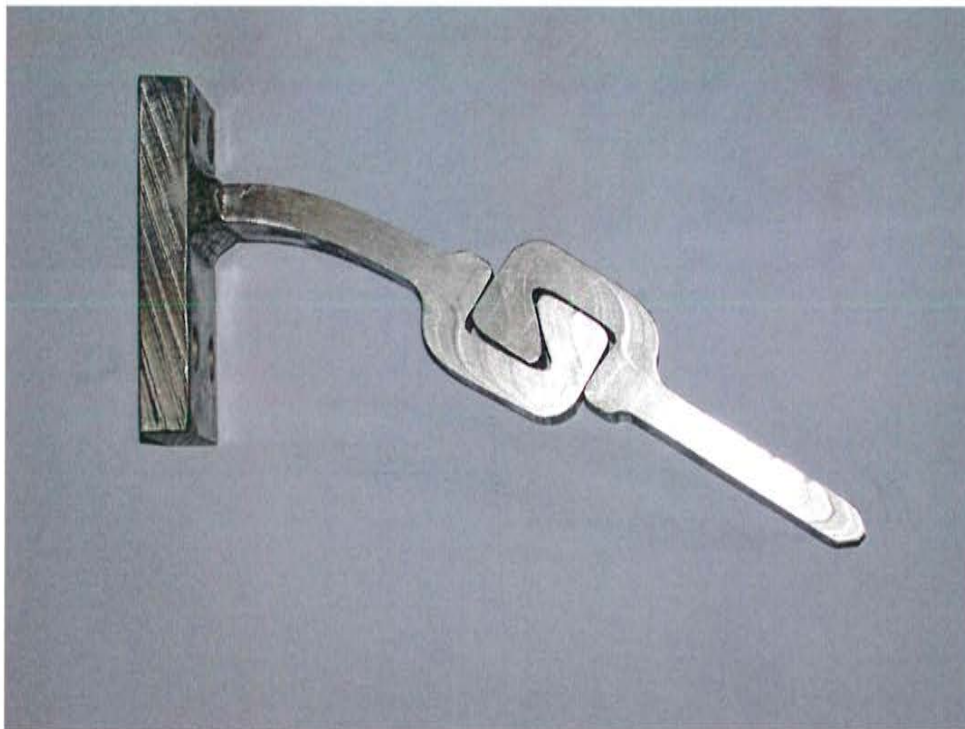
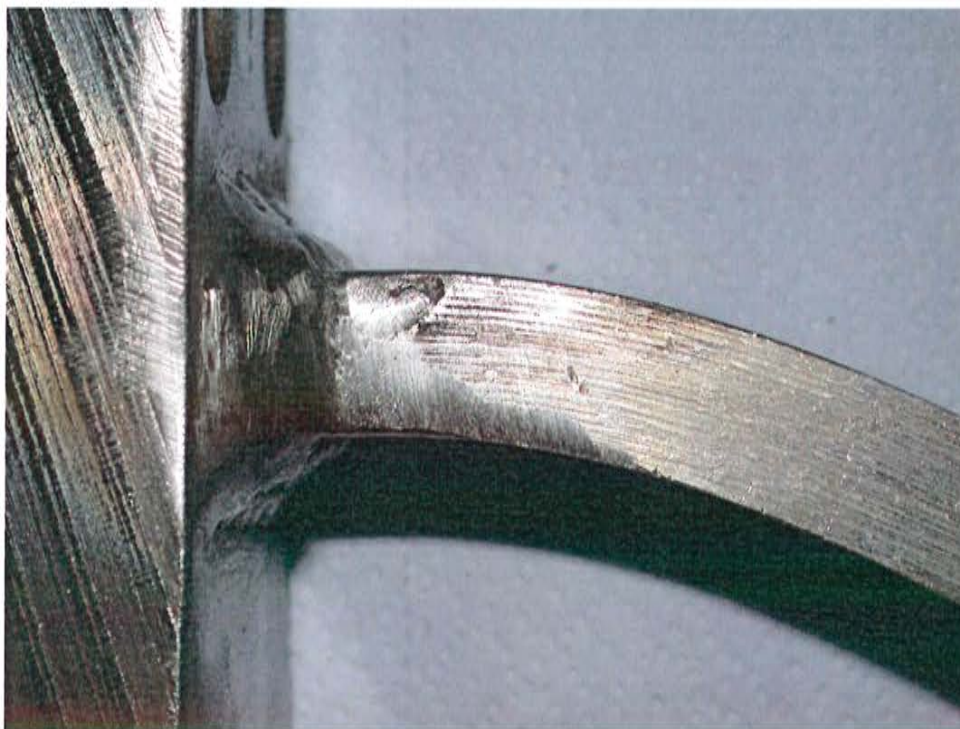
Figure 21:
Overview photo, sample no. 5 (LBP300-16),
Deformation after test

Figure 22:
Overview photo, sample no. 5 (LBP300-16),
Deformation after test

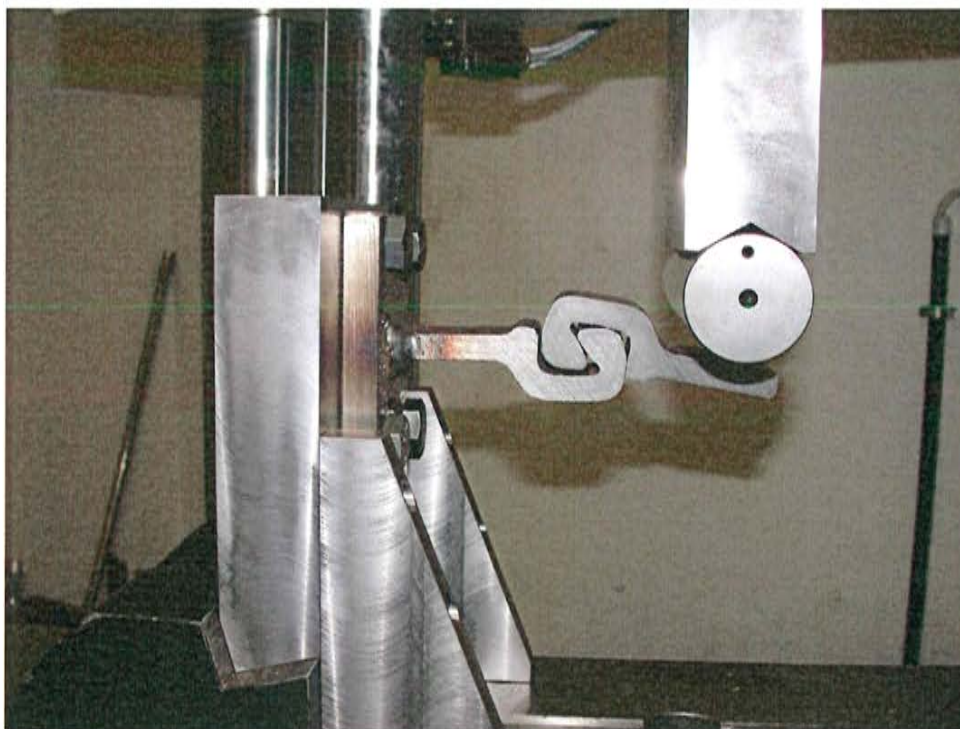
Figure 23:
Overview photo, sample no. 8 (LBP180-12),
Test setup

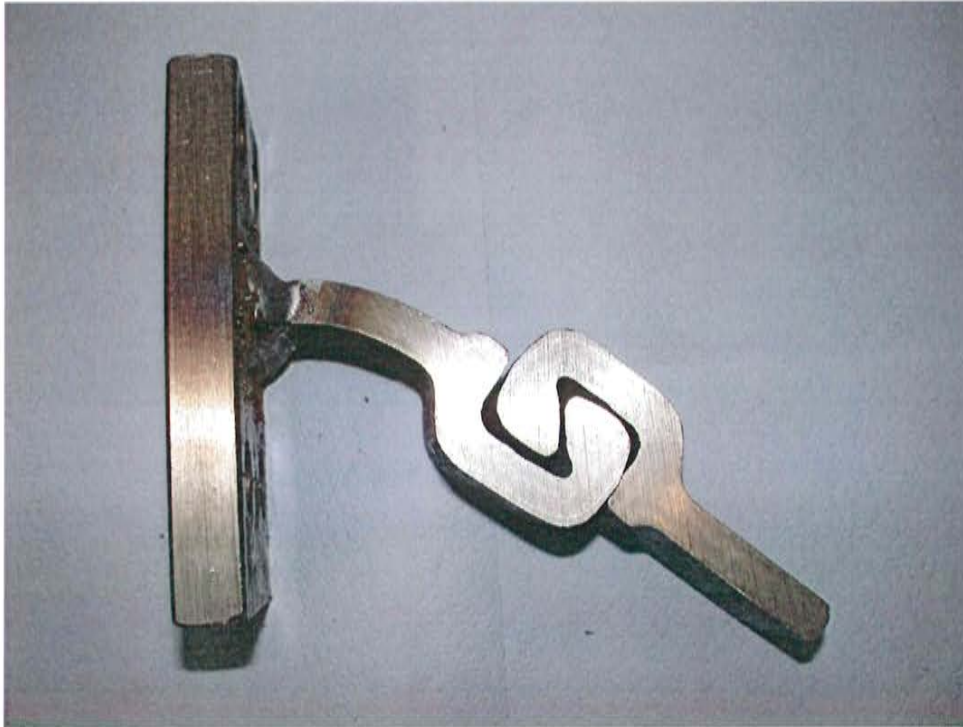
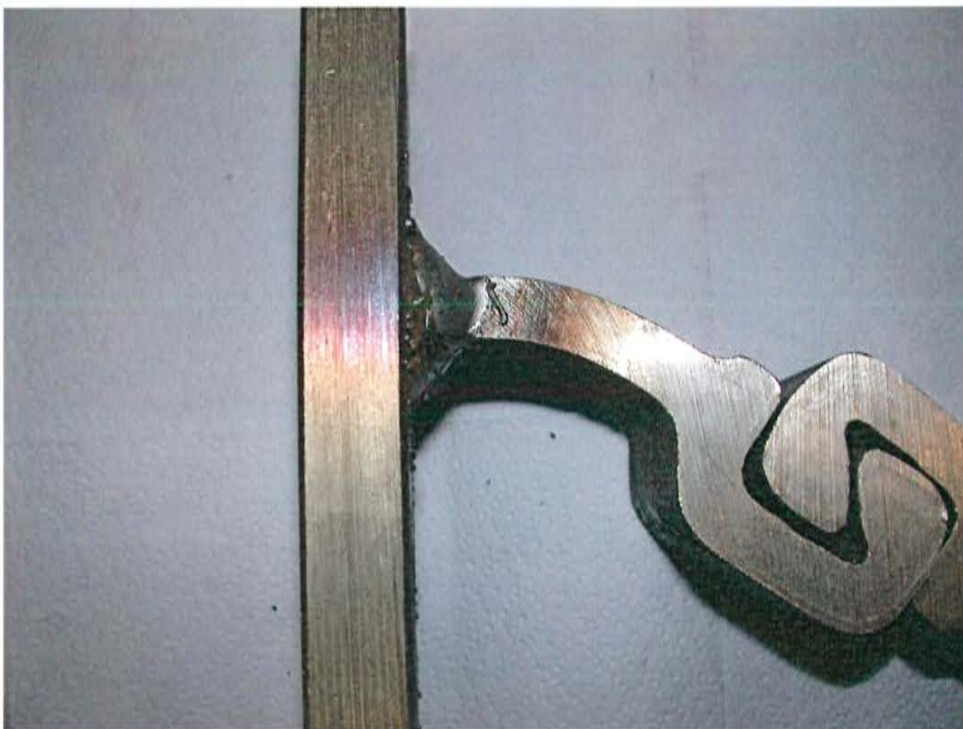
Figure 24:
Overview photo, sample no. 8 (LBP180-12),
Deformation after test

Figure 25:
Overview photo, sample no. 8 (LBP180-12),
Deformation after test

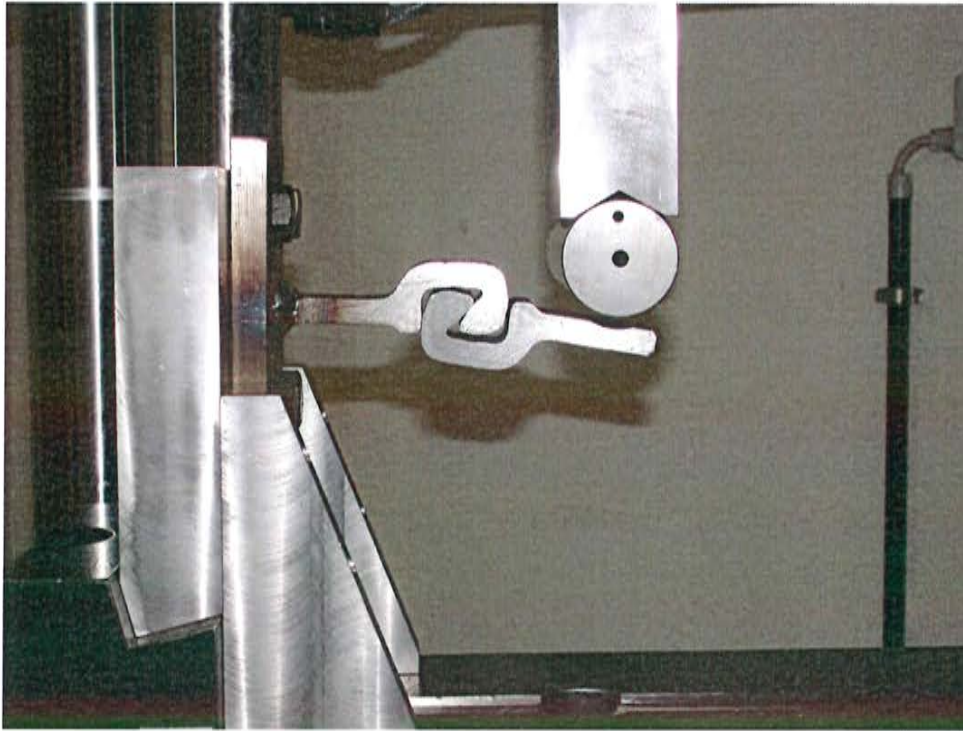
Figure 26:
Overview photo, sample no. 9 (LBP180-12),
Test setup

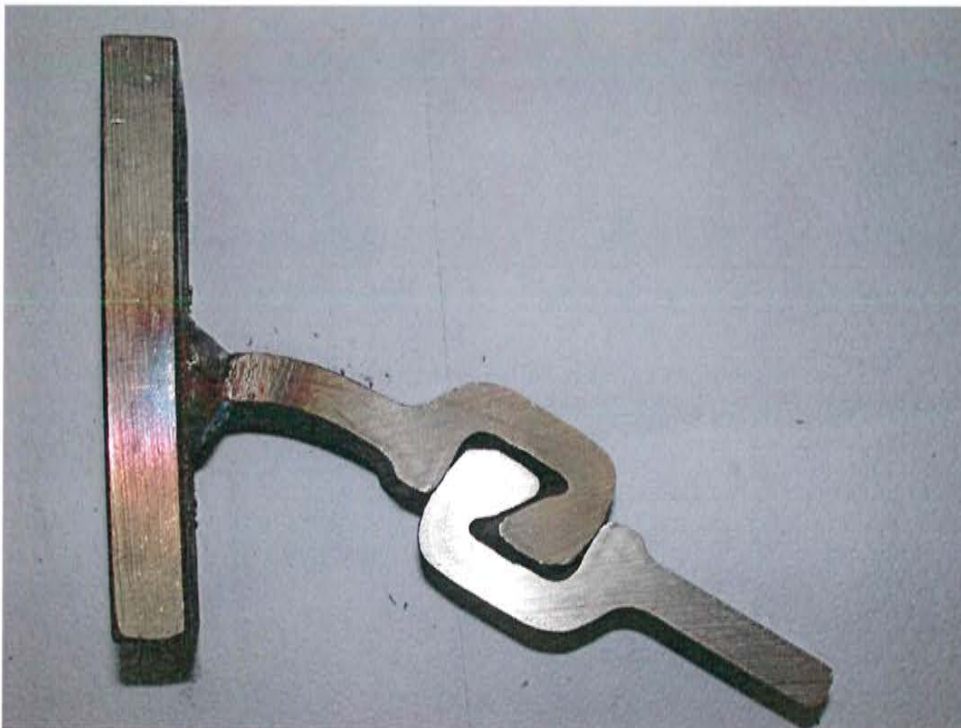
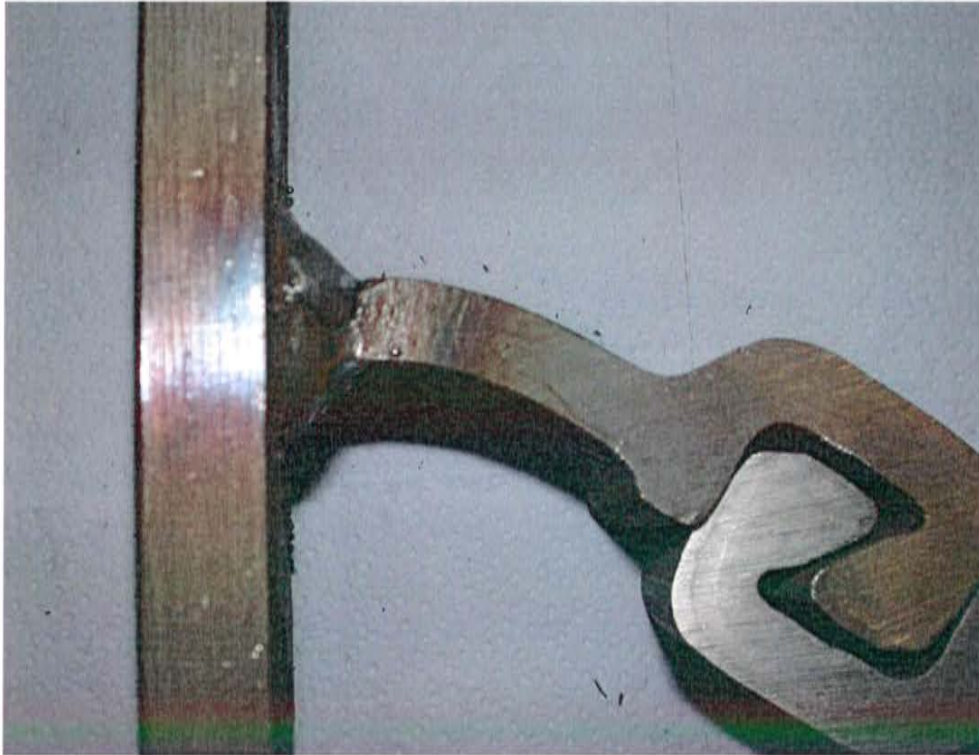
Figure 27:
Overview photo, sample no. 9 (LBP180-12),
Deformation after test

Figure 28:
Overview photo, sample no. 9 (LBP180-12),
Deformation after test

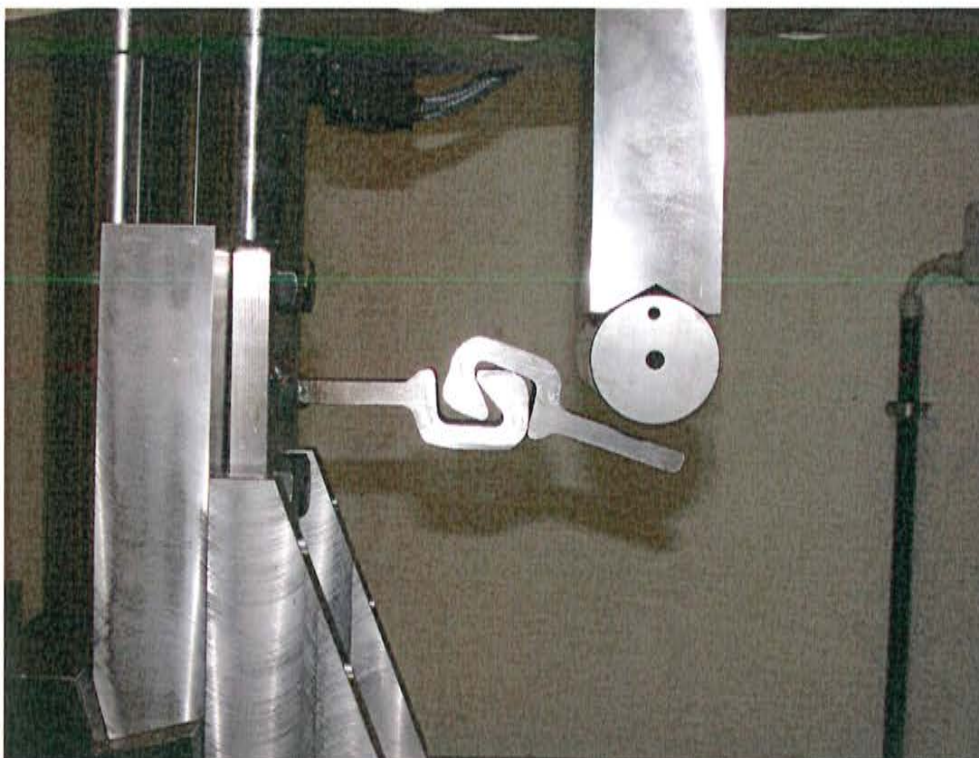
Figure 29:
Overview photo, sample no. 12 (LBP180-10),
Test setup

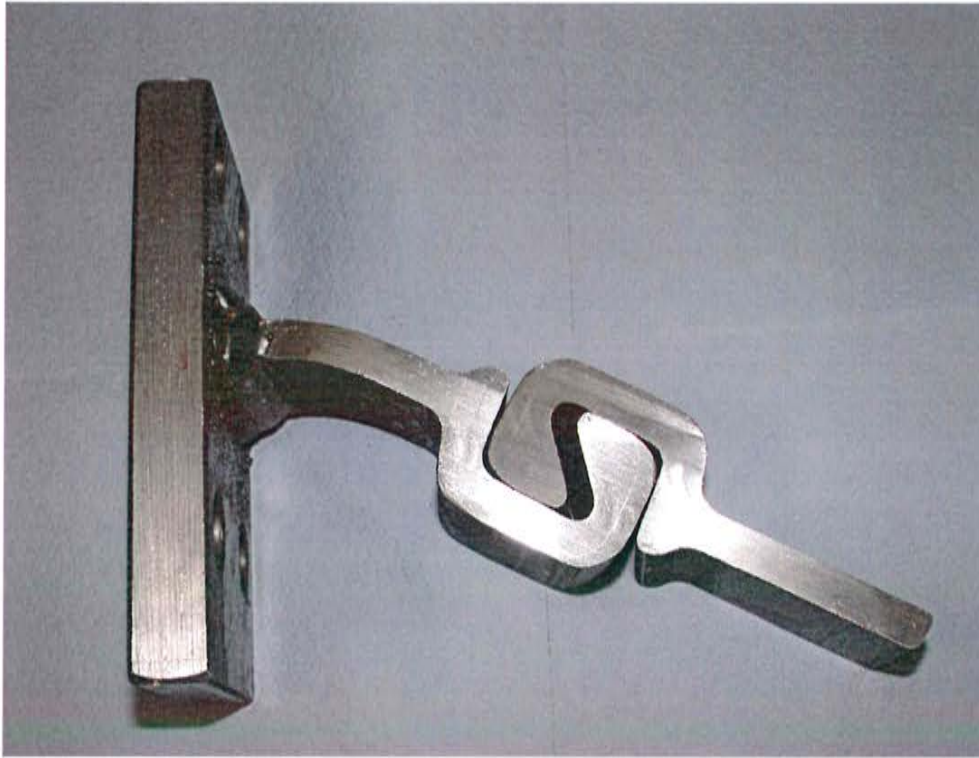
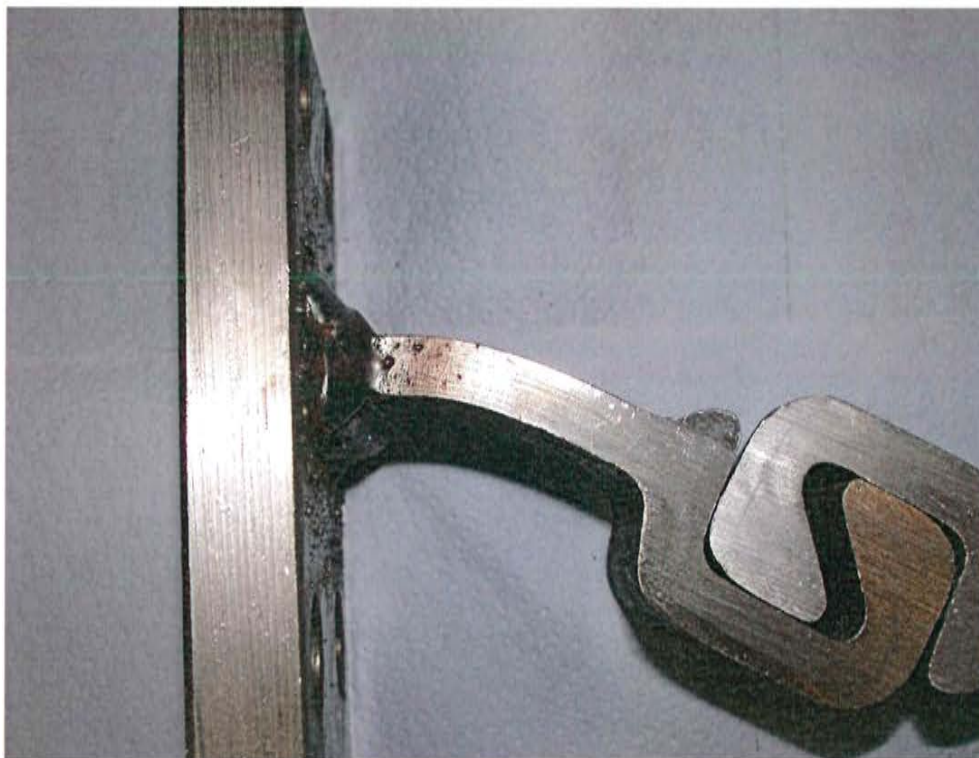
Figure 30:
Overview photo, sample no. 12 (LBP180-10),
Deformation after test

Figure 31:
Overview photo, sample no. 12 (LBP180-10),
Deformation after test
