Test report no.: 16/655/0276

Title: Tensile and bending test on sheet piling clutch bars

Client: SteelWall ISH GmbH
Tassilostr. 21
82166 Gräfelfing

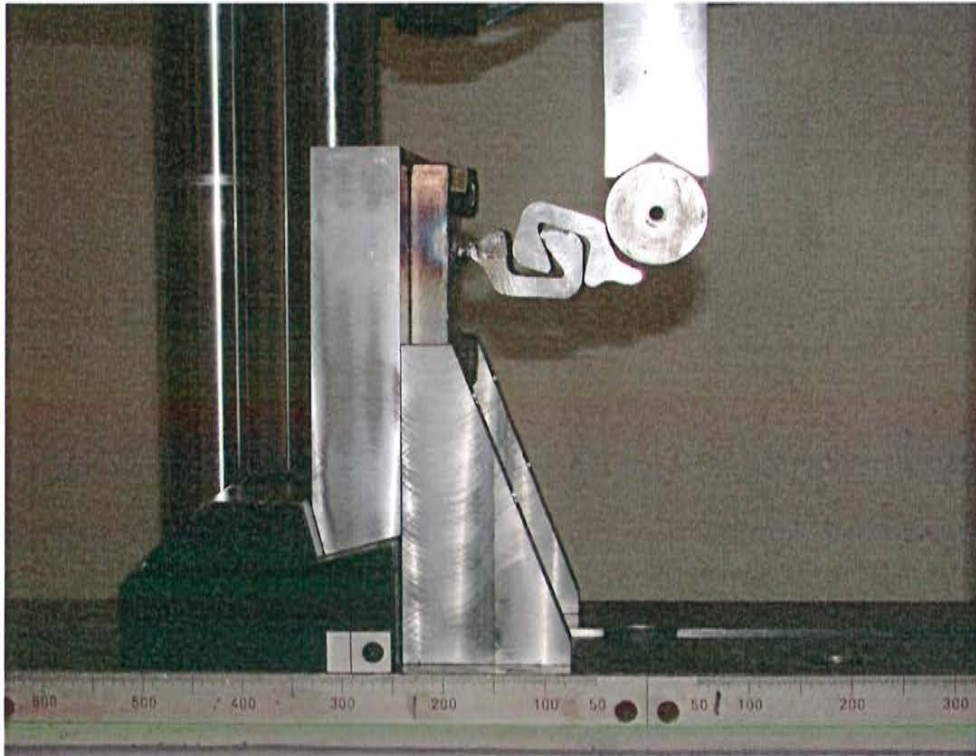
Figure 32:
Overview photo, sample no. 15 (LBP100-10),
Test setup

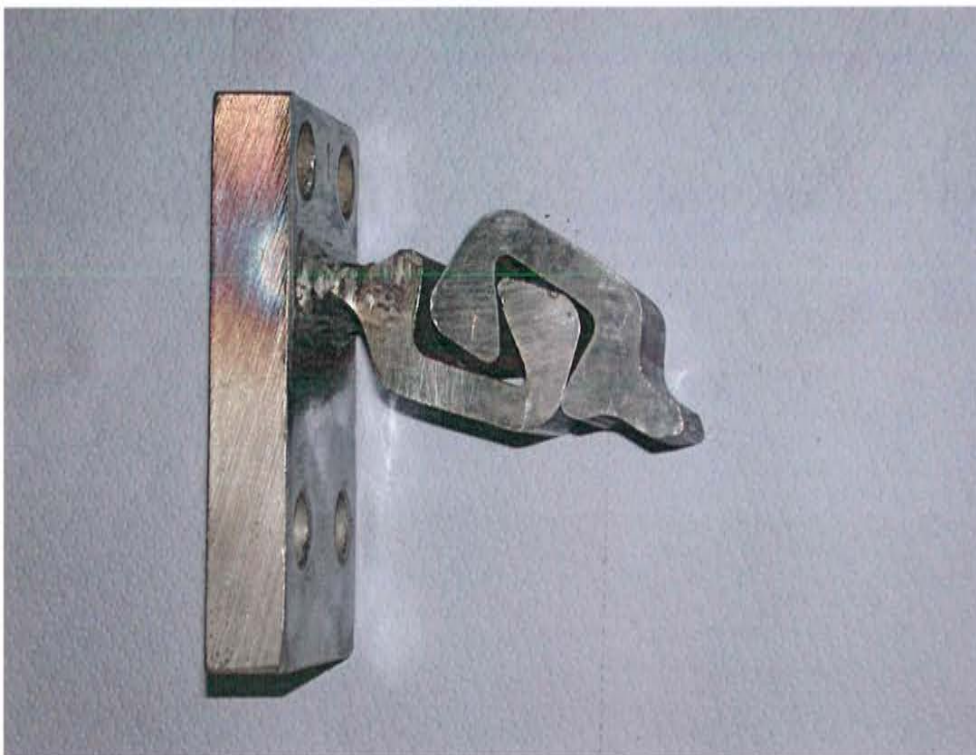
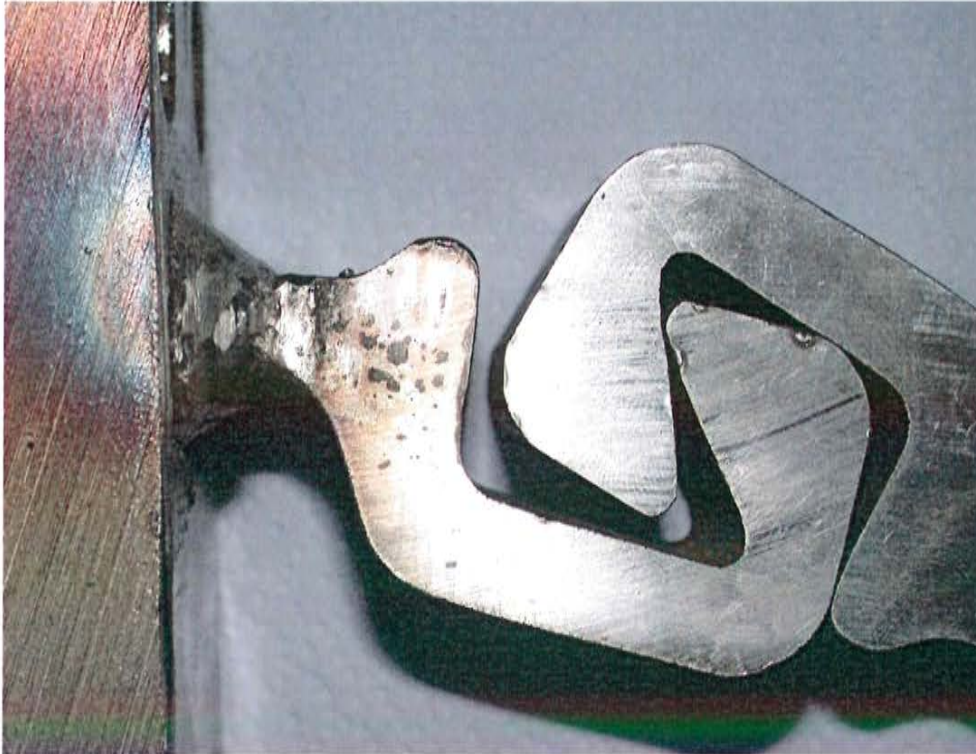
Figure 33:
Overview photo, sample no. 15 (LBP100-10),
Deformation after test

Figure 34:
Overview photo, sample no. 15 (LBP100-10),
Deformation after test

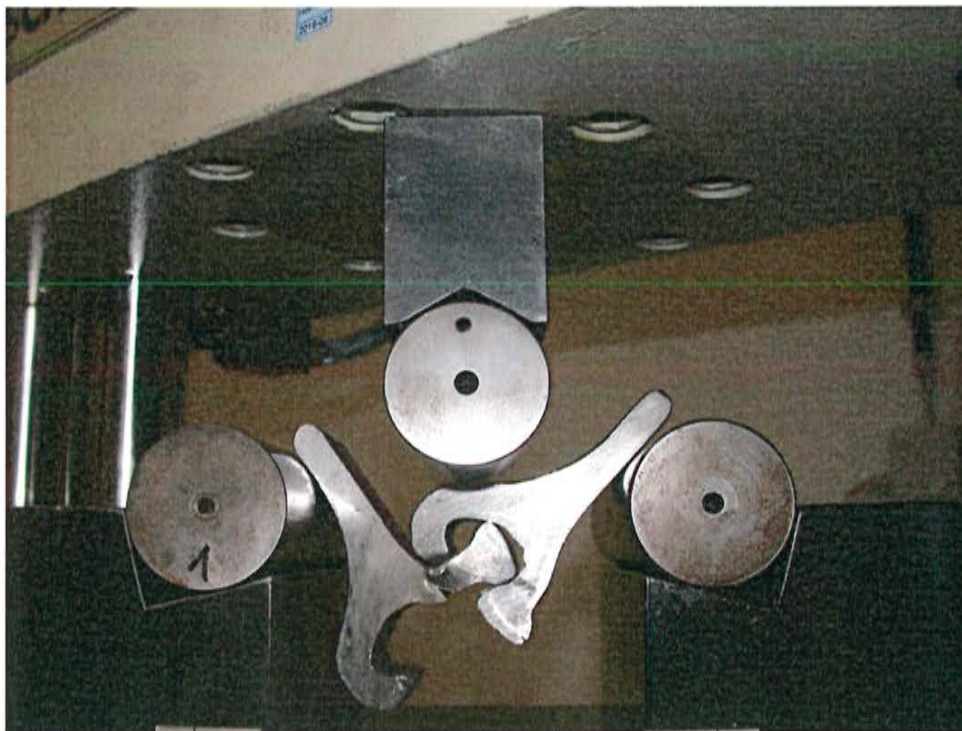
Figure 35:
 Overview photo, bending device

Secondly a three point bending test was performed, where a bending stamp pushed on the paired clutch bars and support was provided by the welded ends of the clutch bars. This test simulates force applications in the driving procedure as well.

Figure 35 shows the test setup for the bending tests.

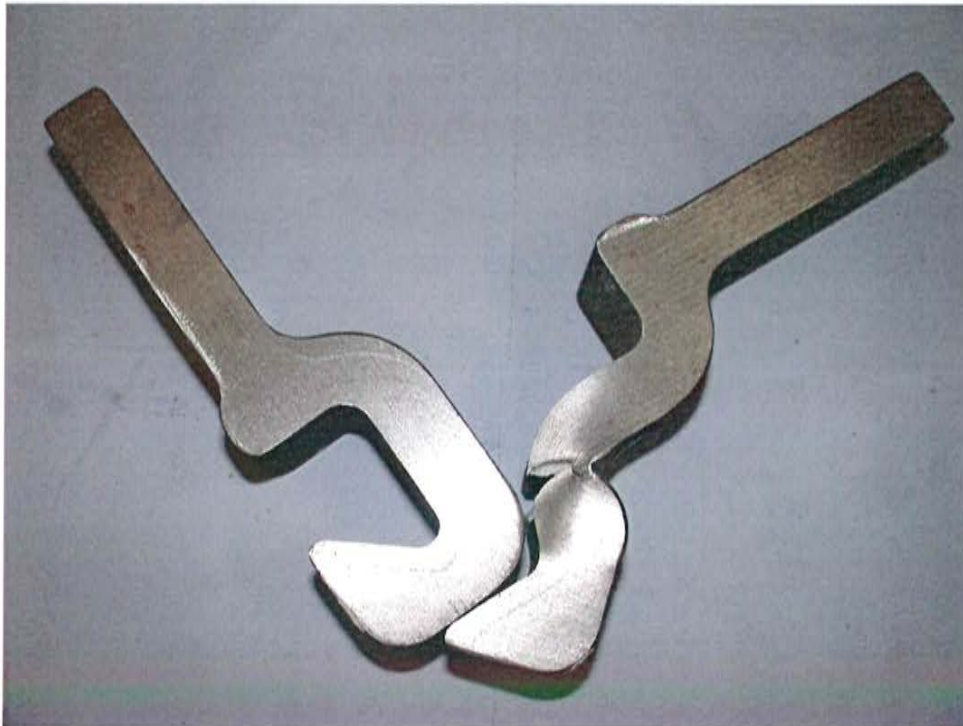
Figure 36:
Overview photo, sample no. 3 (LBP300-20),
Deformation with break after test

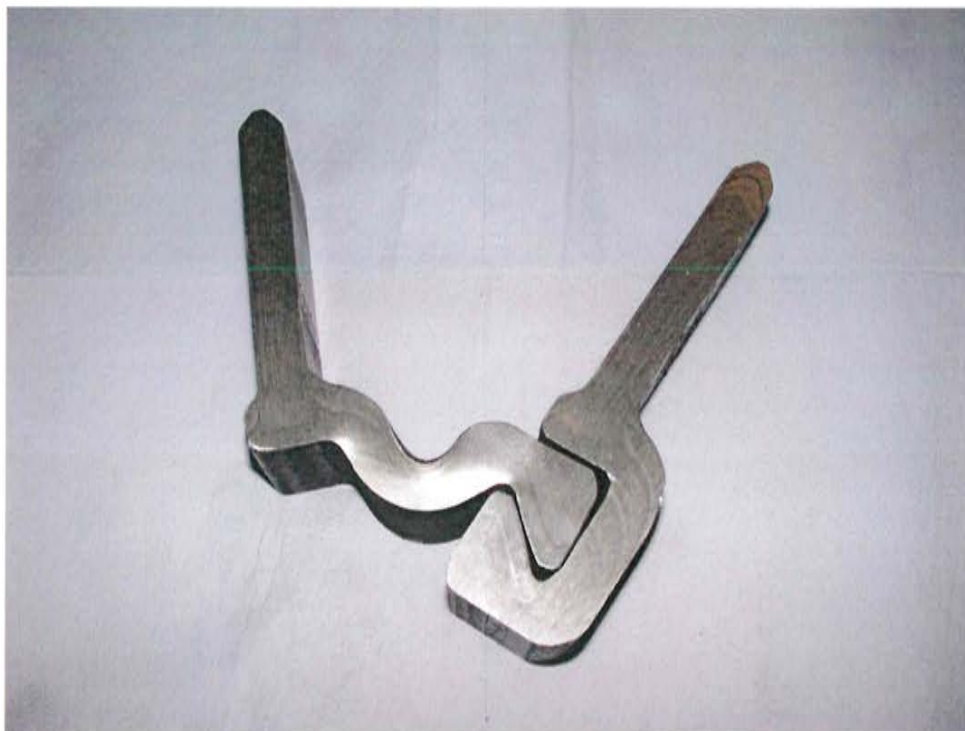
Figure 37:
Overview photo, sample no. 6 (LBP300-16),
Deformation after test

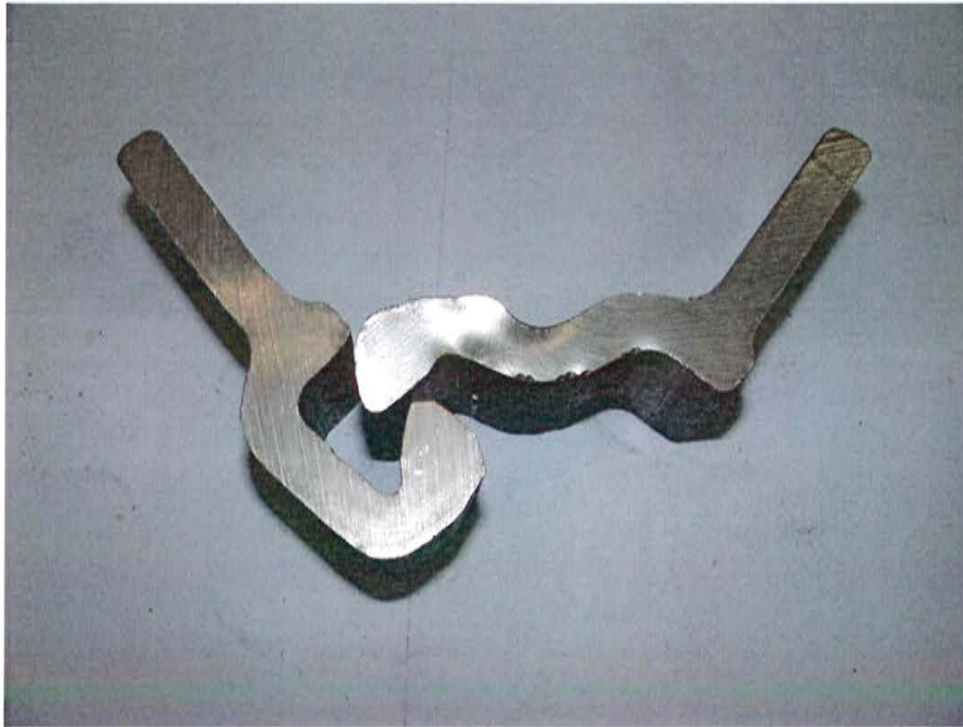
Figure 38:
Overview photo, sample no. 10 (LBP180-12),
Deformation after test

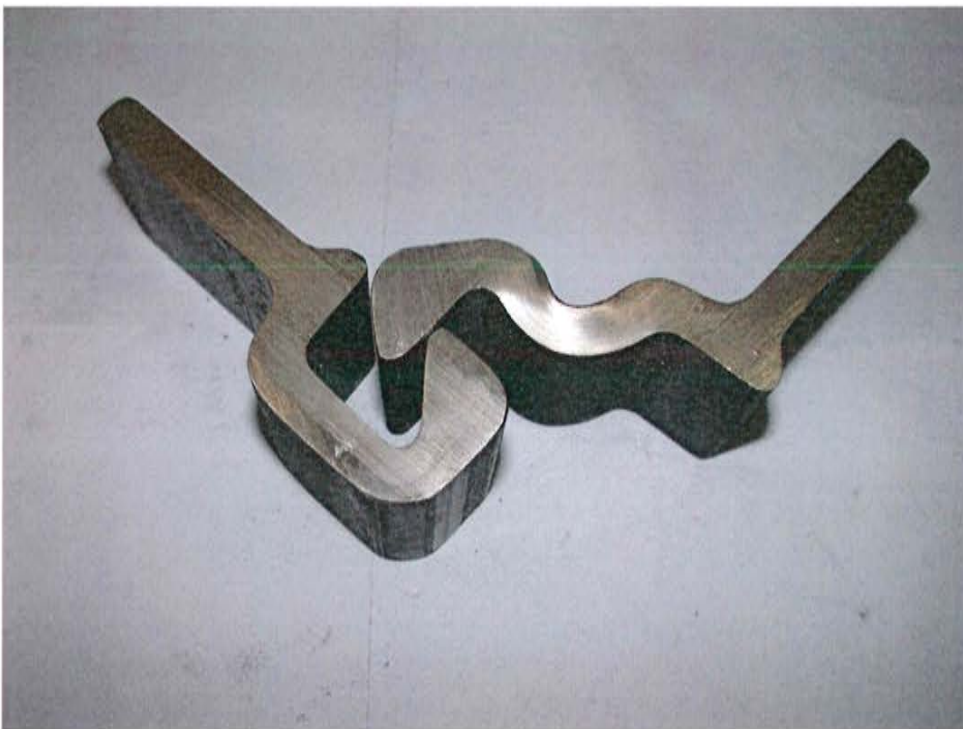
Figure 39:
Overview photo, sample no. 13 (LBP180-10),
Deformation after test

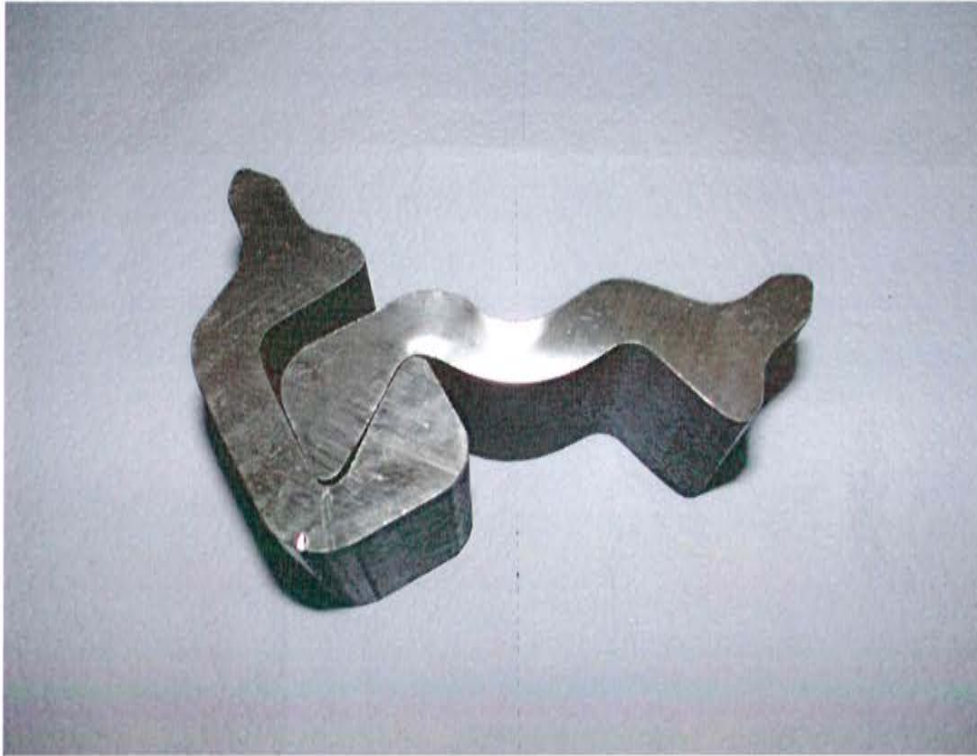
Figure 40:
Overview photo, sample no. 16 (LBP100-10),
Deformation after test

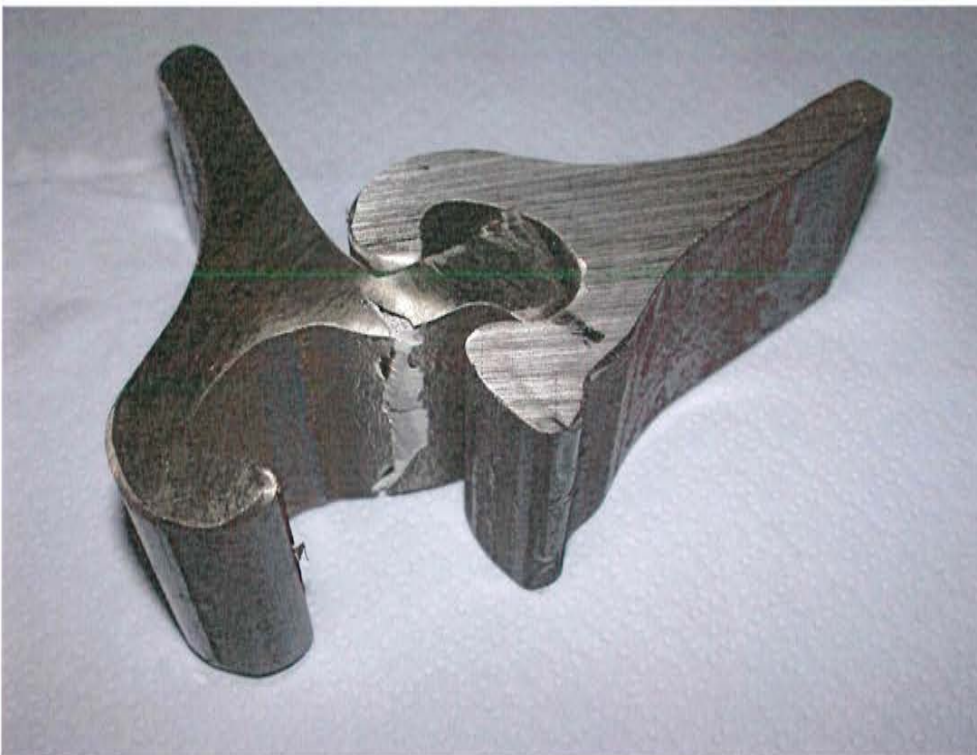
Figure 41:
Overview photo, sample no. 18 (FD180-12),
Deformation with break after test

To safely store the samples for the three-point bending test, the clutch bars PZM-US / PZF-US were extended by welding on plates. A bending mandrel with diameter 40 mm was chosen as bending stamp for profiles PZM-US/PZF-US Ø20 mm. Profile FD180-12 achieved a bending angle of approx. 105° and profile PZM-US/PZF-US one of approx. 65°. All other clutch bars were bent to approx. 180°. Figures 36 to 43 document the individual clutch bars after the bending test.

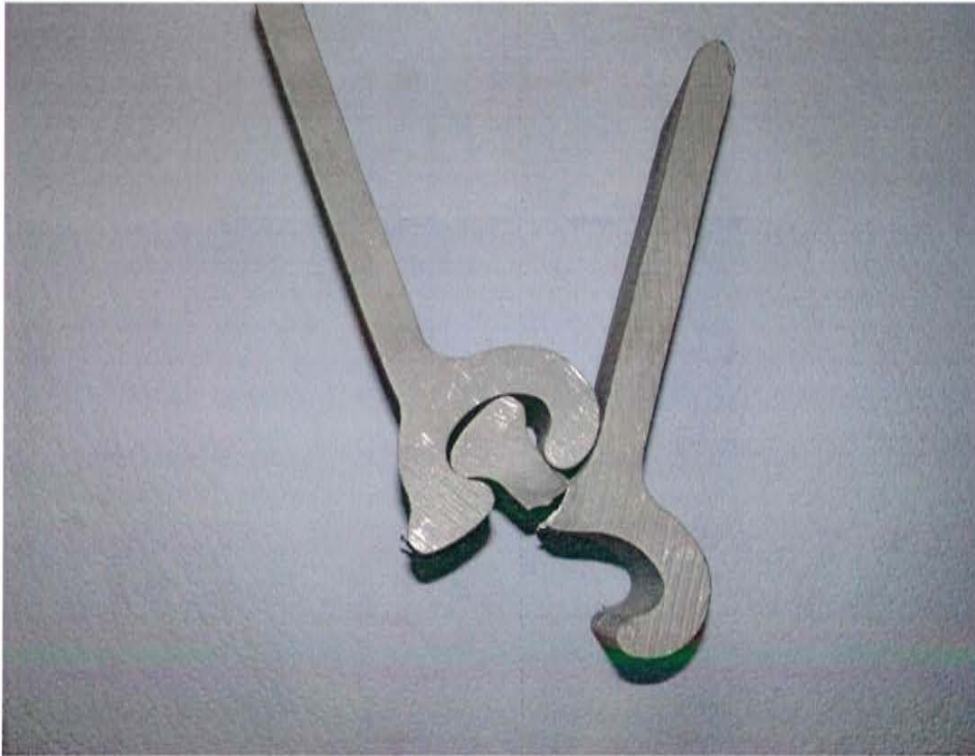
Figure 42:
Overview photo, sample no. 20 (FD300-12),
Deformation after test

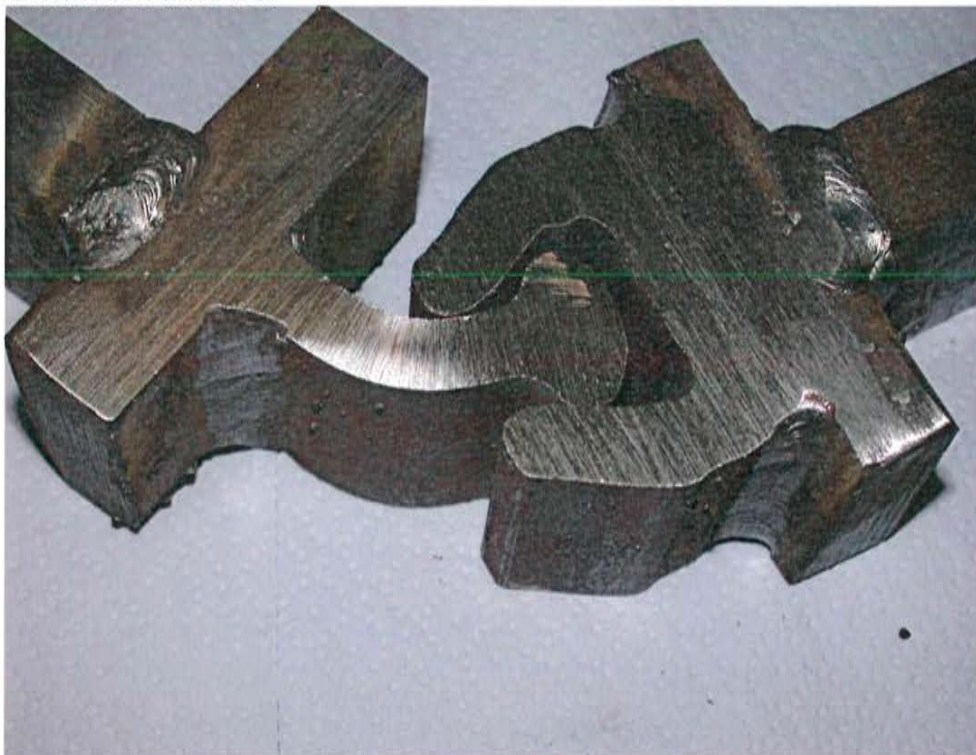
Figure 43:
Overview photo, sample no. 22 (PZM/PZF),
Deformation after test
